TAS 202 and AAMA 501 TEST REPORT

Report No.: C5554.02-550-44

CARDINAL COMMERCIAL PRODUCTS
Louisville, Kentucky

PRODUCT TYPE: Framing System – Storefront
SERIES/MODEL: CF451 (Exterior Glazed)

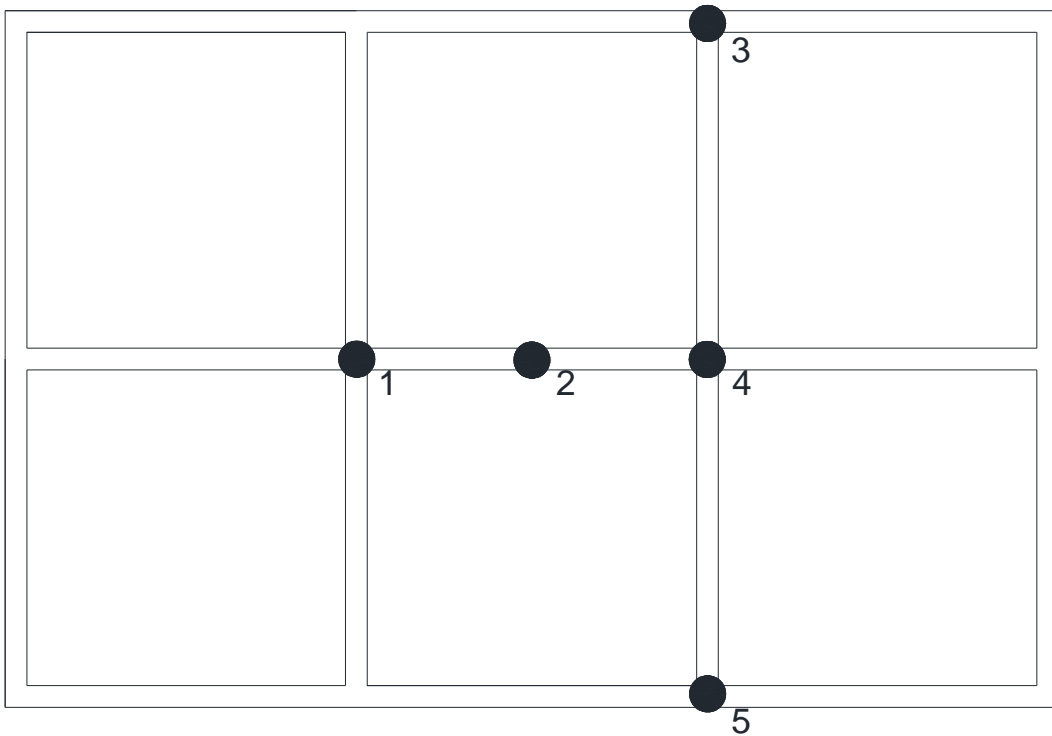
Sketch #1 – Deflection Gage Locations

Note # 1: See Architectural Testing Sketch #1 for indicator locations. Location # 2 (middle horizontal), and Location # 4 (right vertical mullion) take account for support movement. Data shown is final.

Indicator Reading (inches)	
	# 2	# 4
Structural Loads 50% of Test Pressure (+26.25 psf)	# 2	# 4
Maximum Deflection	0	0.362
Permanent Set	0	0.002
% Recovery	100.00	99.59
Design Pressure (+35 psf)	# 2	# 4
Maximum Deflection	0.039	0.390
Permanent Set	0.002	0
% Recovery	94.81	100.00
50% of Test Pressure (-26.25 psf)	# 2	# 4
Maximum Deflection	0.037	0.292
Permanent Set	0.002	0.007
% Recovery	94.52	97.77
Design Pressure (-35 psf)	# 2	# 4
Maximum Deflection	0.052	0.394
Permanent Set	0.005	0.011
% Recovery	90.29	97.34
Water Infiltration (+15.00 psf)	PASS	
Test Pressure (+52.5 psf)	# 2	# 4
Maximum Deflection	0.061	0.621
Permanent Set	0.001	0.004
% Recovery	99.17	99.36
Test Pressure (-52.5 psf)	# 2	# 4
Maximum Deflection	0.082	0.604
Permanent Set	0.005	0.017
% Recovery	93.90	97.18

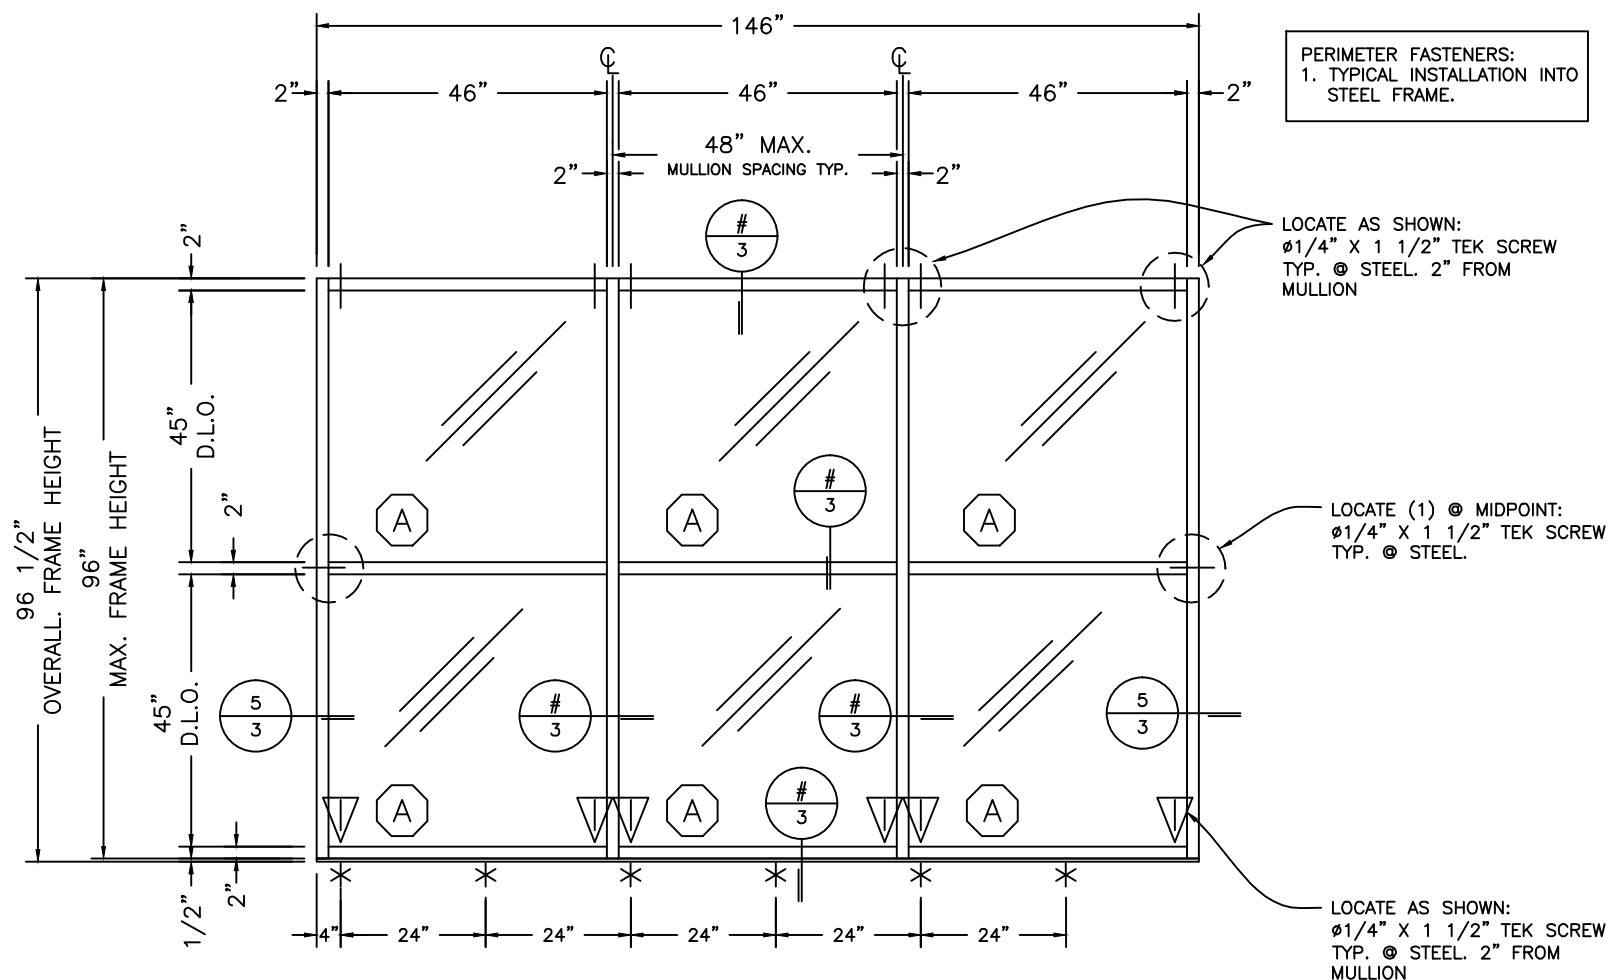
E1
TYPICAL ELEVATION
EXTERIOR GLAZED
WITH STANDARD CF451-1
VERTICAL MULLION

* = 1/4" X 3/4" WEEP SLOT
4" FROM END AND 24" CENTER TO CENTER

1. TESTING AIR, WATER, AND STATIC
2. D.L.O.= DAYLIGHT OPENING
3. GLASS SIZE = D.L.O. + 7/8"

1. DESIGN PRESSURE = +35/-35 PSF
2. AIR TEST AT 6.24 PSF
3. WATER TEST AT 15 PSF
4. MAXIMUM DEFLECTION = 0.549"

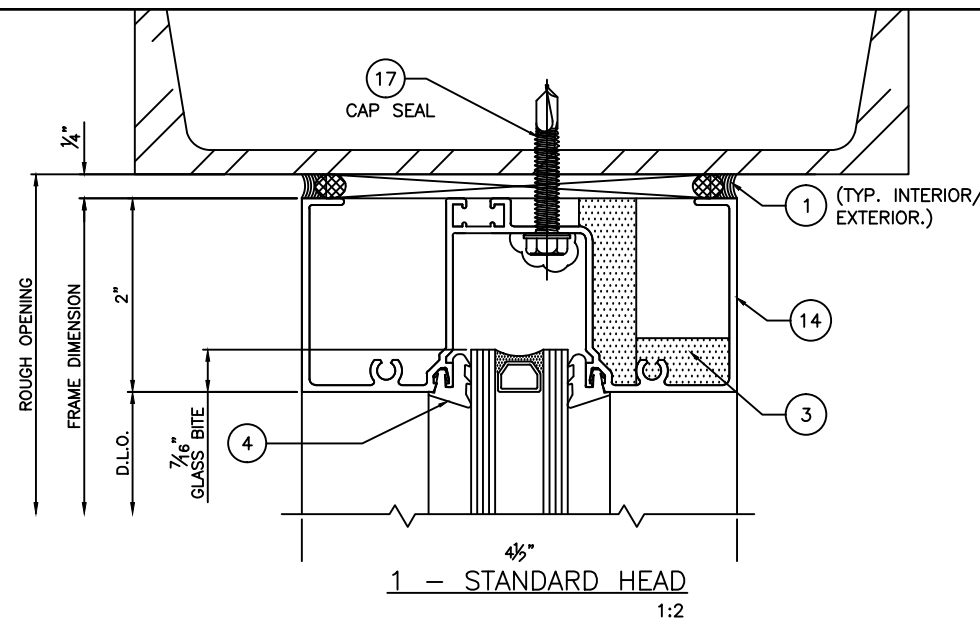
1 - STANDARD HEAD
1:2

- 1 TYPICAL PERIMETER SEALANT
- 2 TYPICAL INTERIOR SEALANT
- 3 TYPICAL @ ALL JOINT INTERSECTIONS
- 4 TYPICAL EXTERIOR/INTERIOR GASKET
- 16 TYPICAL AT ALL SPLINES
